**Tilt Mechanism Testing on Office Chair Sample  
Sample ID – Multi-axial, Single Resistance Ergonomic Office Chair  
ANSI/BIFMA X5.1-2017**

A Report to: **CoreChair Inc.**  
14845-6 Yonge Street, Suite 248  
Aurora, Ontario  
L4G 6H8

Report No.: 19-06-C0178  
3 Pages, 3 Figures

Date: November 28, 2019

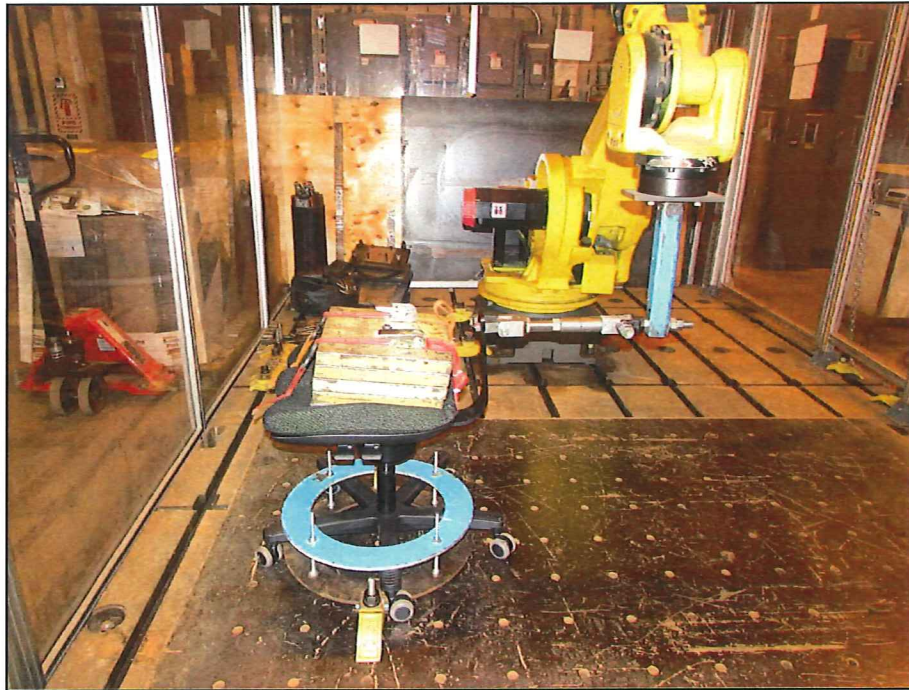
Figure 1 : Tilt mechanism test set-up

The chair sample was seated on the test platform and restrained from movement at its base. A weight of 240 lbs was secured on the centre of the seat. A programmable robotic arm was used to cycle the tilt mechanism between front and back stops (motion restricted to front-back direction using a set of clevises – chair not stable sideways when the weight is applied). The test was performed up to 300,000 cycles or to failure, whichever occurs first.

The photos of the test set-up are presented in Figures 1 and 2.

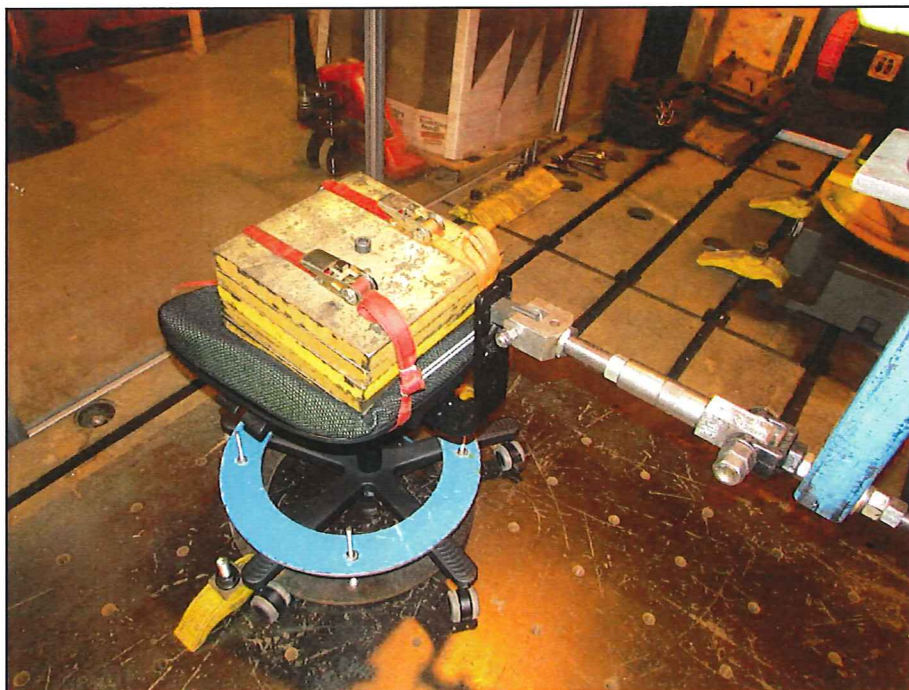
Figure 2 : Tilt mechanism test set-up

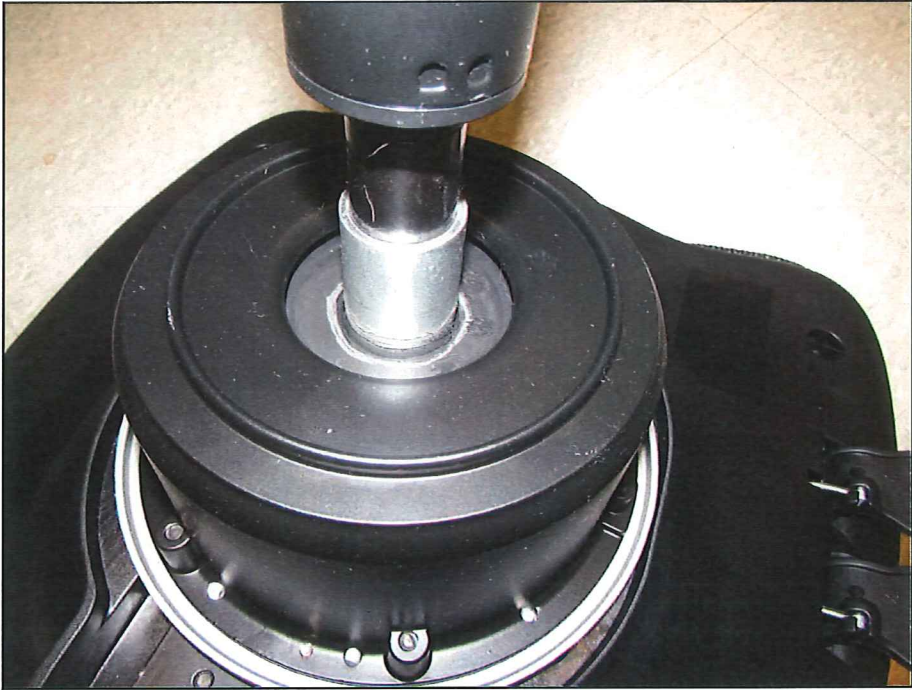
Figure 3 : Tilt mechanism at test completion

Test Description	Standard Section	Test Results
Tilt Mechanism	9	The mechanism completed 300,000 cycles of tilt mechanism travel without failure or loss of serviceability and passed the test requirement

The photo of the tilt mechanism at test completion is presented in Figure 3.
